FIG WORKING WEEK 2012

Disaster Monitoring Using Remote Sensing for the Great East Japan Earthquake

PASCO CORPORATION

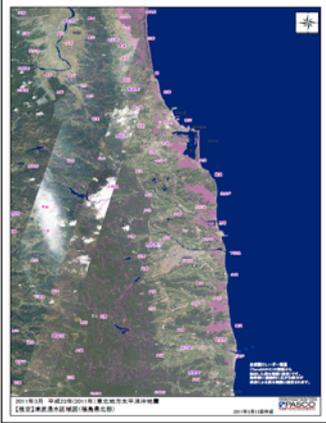
Est. affected area by tsunami
Northern part of Fukushima
Around nuclear power plant
Using TerraSAR-X

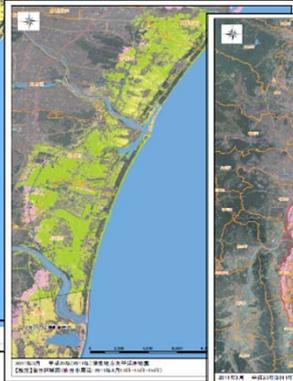
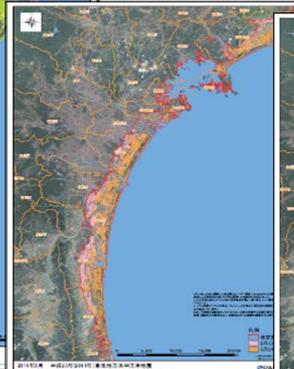
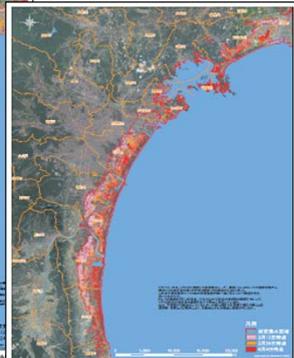
Inundation Monitoring Using TerraSAR-X around SENDAI

Daily report update of inundated areas for Automatic change detection

Ten times Observation using TerraSAR-X between March 13 and April 4

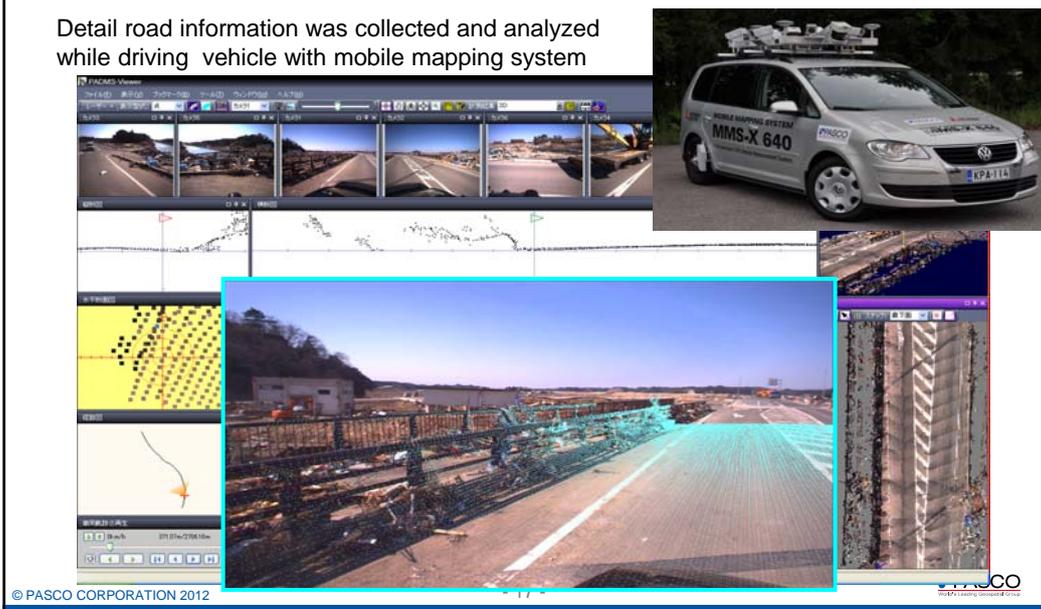
Road damage assessment by MMS

Detail road information was collected and analyzed while driving vehicle with mobile mapping system

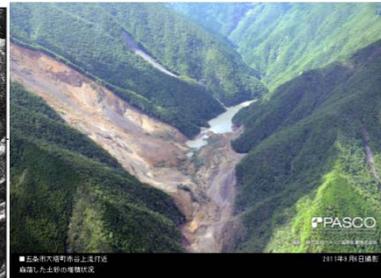
Landslide dam(Oblique Photo(Sep.6)
